Chelmsford School for Girls Pool - A Summary of Structural Investigations

We write further to our inspection of the reported cracking and structural damage to the swimming pool building sited at Chelmsford School for Girls, and to give commentary on our investigations and findings over the summer period.

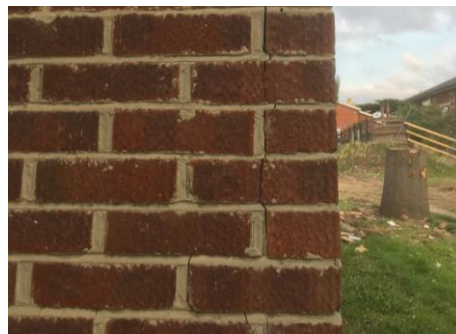
Cracking has appeared in the masonry to the north east of the building. The cracks were found to be predominately running vertically refer to figure 1

Figure 1: Cracking to The North East Corner with Tree Stump in Distance

- Discussion with site manager found that a tree has been removed
- The foundations are founded on a Clay stratum
- Soil investigation found that the clay has Medium to High Volumetric change, and NHBC guidance shows that the trees proximity to the foundation is within the zone of influence of the building and would likely cause the observed damage

- It is our view that the removal of the tree and subsequent “drying out” of clay is causing the observed settlements and cracks. We recommend therefore that the ground be allowed further time to settle before carrying out repair works to masonry.
- The reader should note that the masonry is not in a good state of repair and could become unsafe, we recommend that during the ground settlement period the Client employs a management procedure which includes regular inspections of the cracking focusing on changes in cracking patterns or increase in crack size. A regular report should be submitted to the engineer and surveyor.
- Once the monitoring has demonstrated that the movement has diminished, we recommend a full condition survey from a scissor lift be carried out and further advice on suitable repairs be sought.

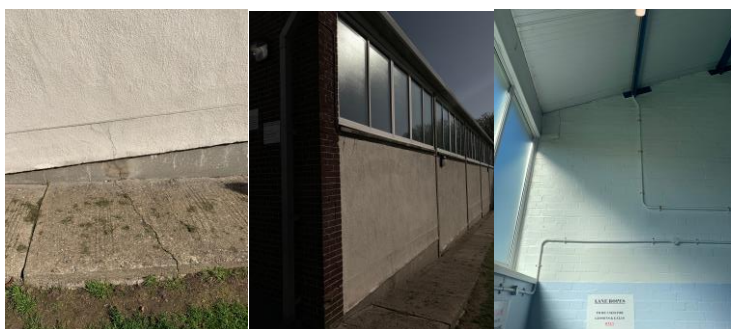
To the southwest of the site cracking was observed in the façade and adjacent ground and appears to be progressive in settlement.

Figure 2: Internal and External Cracking

- Trial pit investigation found footings locally sitting on sandy clay granular made ground and unlike elsewhere the wall’s foundation did not reach to natural stratum.
- Movement monitoring is currently on going and has recorded progressive movement

Trial pits show that foundations are on a made ground stratum. As clay was not found in the limited soil investigation carried out, it is unlikely that movement is due to ground heave and that more likely the cause is a progressive destabilisation of the made ground which will ultimately result in the destabilisation of the wall causing a serious health and safety risk. **We recommend therefore that the wall be stabilised as soon as practicable** using Helifix piles down to the stable clay stratum to ensure the building remains functional this is detailed on ISL drawing 19052/01

Though it is our view that the building can remain operational subject to the works described in paragraph three being carried out, because of the risk of cracking, we would not recommend that funds be committed to any significant refurbishment without stabilising works to the foundations being carried out. ISL drawings 19052 series make recommendations on how this might be achieved.
